UNITED STATES ENVIRONMENTAL PROTECTION AGENCY

Re: Freedom on Information Request
FOIA (8) RIN 193-04
Libby Asbestos Site

I am writing in response to your Freedom of Information Act Request dated April 1, 2004 for all records pertaining to St. John's Lutheran Church, located at 1017 Montana Avenue, and St. John's Lutheran Pre-School and Day Care, located at 1024 Montana Avenue.

Project / Client Libby Asbestos Project

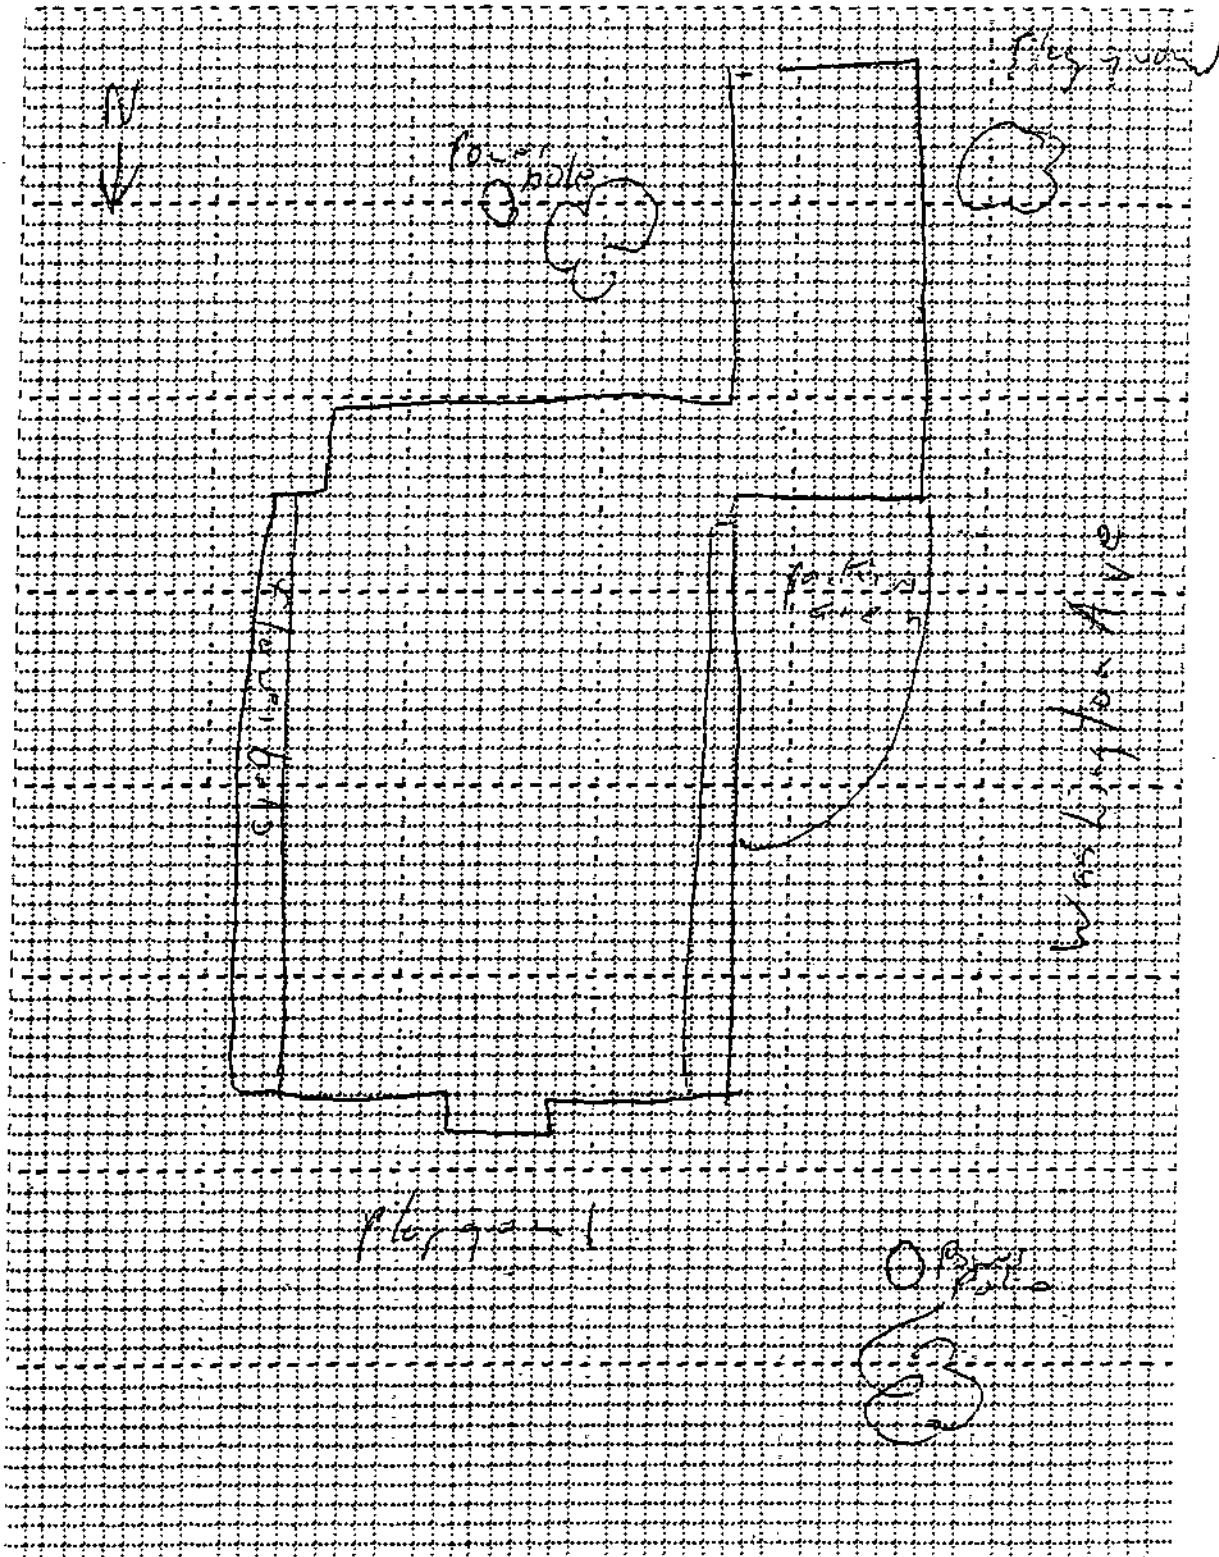
Are primary source materials present at the property?	<u>Yes</u> <u>No</u> DW 8-19-03	
Where are primary source materials located?	Inside Both <u>Outside</u> <u>NA</u> DW 8-19-03	
ADDITIONAL INFORMATION <u>Vacant private school. Fiberglass throughout</u> <u>Not observed in basements. No outdoor equipment</u> <u>DW 8-19-03 Minimal amount of flakes observed in isolated portion of playground near swing set.</u>

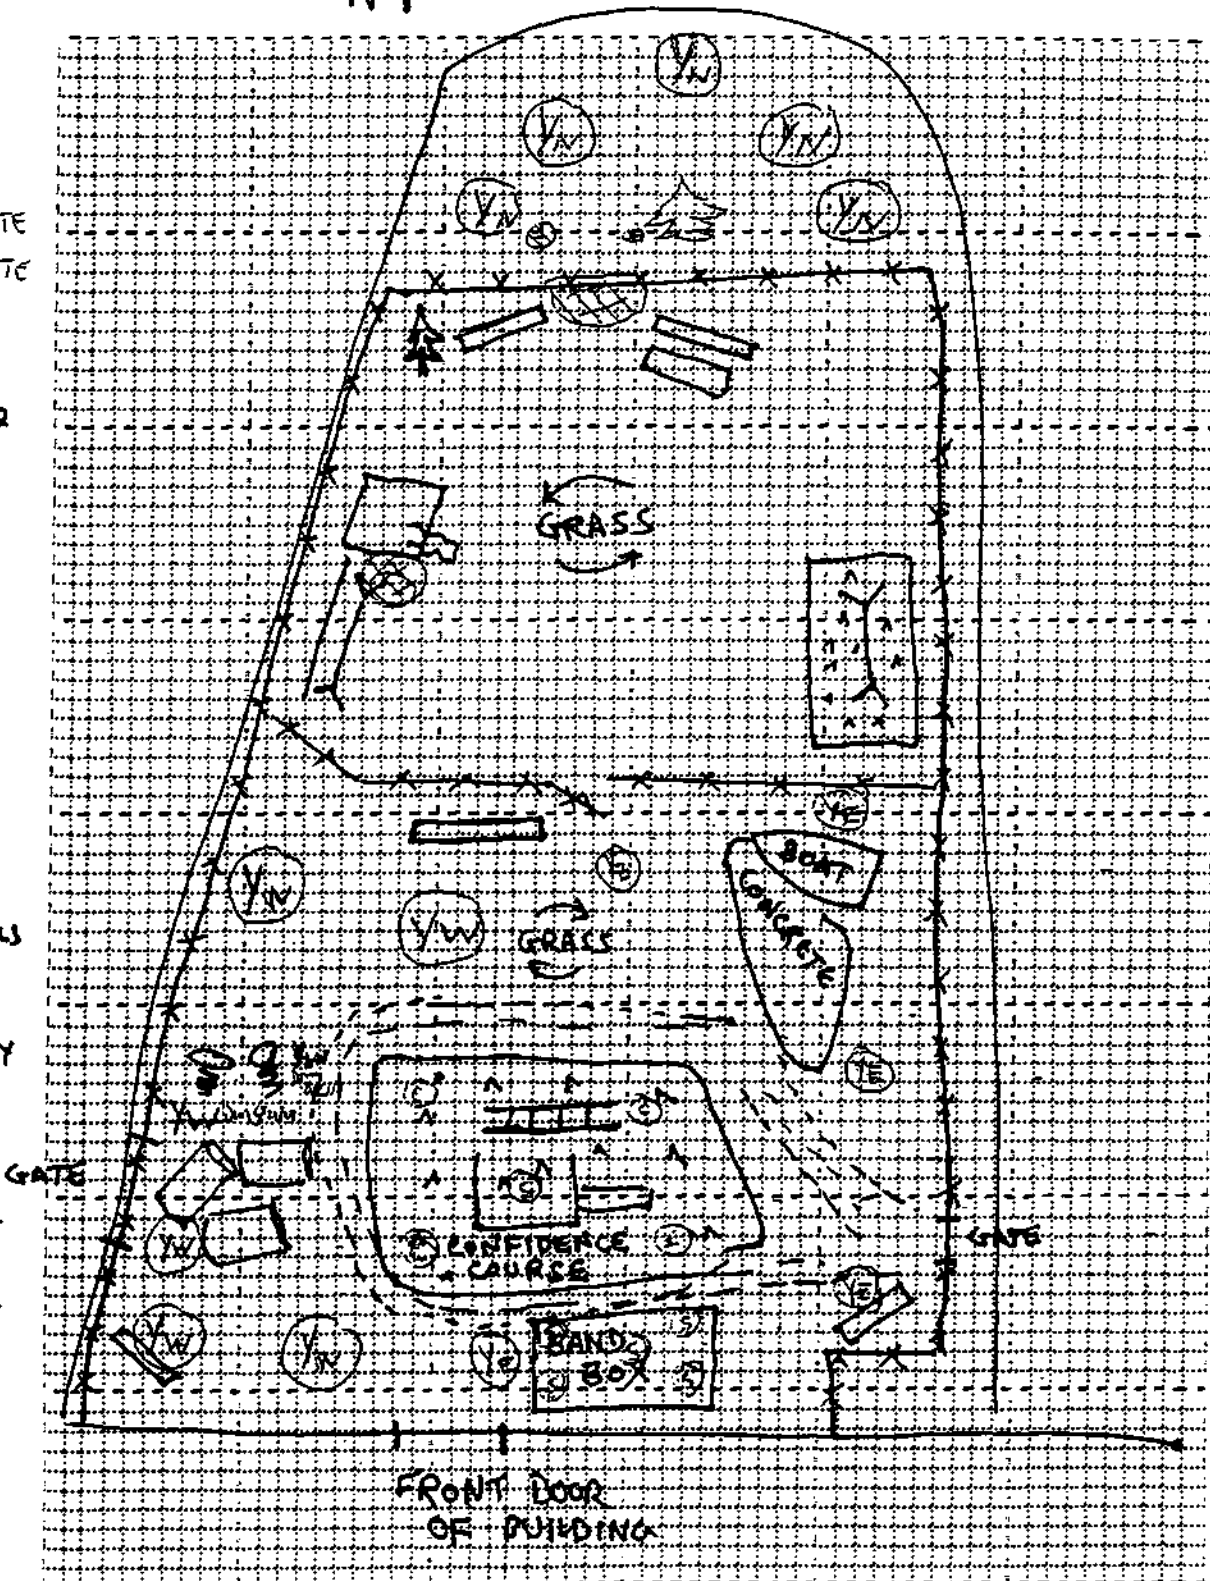
13:45 ON SITE K.V.C.S. TEAM 1, DEE WARREN,
DAVE SCHROEDER, COURTNEY ZAMORA. ON SITE TO
TAKE SOIL SAMPLES IN NORTH SIDE PLAY AREAS,
VISIBLE VERMICULITE AND POSSIBLE TREMBLITE OBSERVED
(SEE SITE SKETCH). SOIL SAMPLES COLLECTED/EQUIPMENT
DECONTAMINATED ACCORDING TO SAP ~~8-21-03~~
